# MODERNIZING A LUMBER PRODUCTION ENVIRONMENT WITH HONEYWELL SLATE AND THERMAL IQ SOLUTIONS

Case Study

# Honeywell and channel partner Martin Control & Equipment Company helps a leading U.S. lumber company upgrade its 30-year-old kiln to satisfy sold-out demand and avoid over \$200K in lost production.

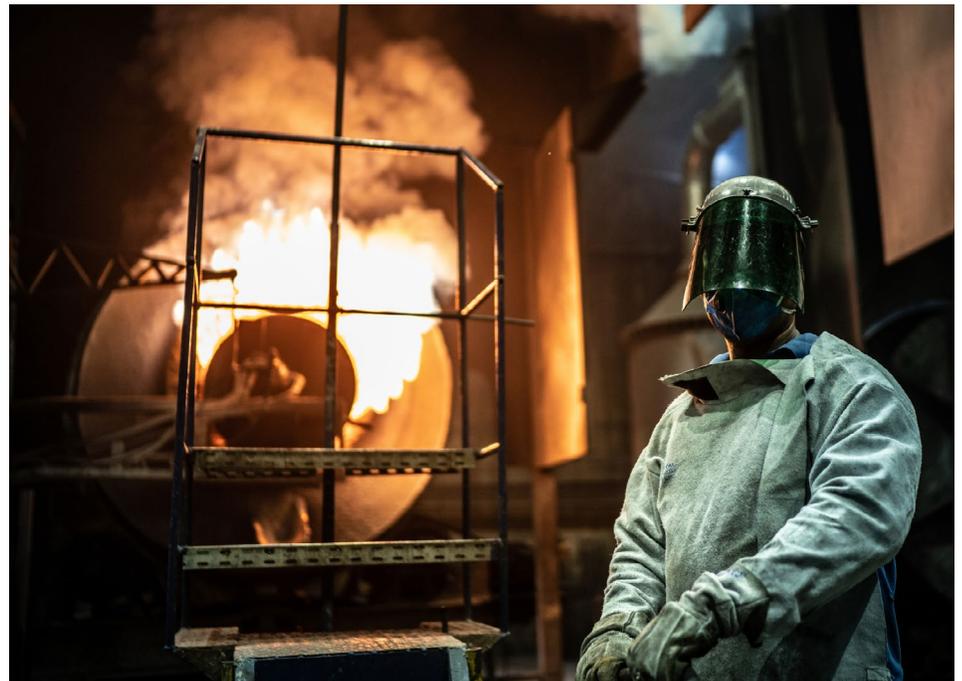
Thermal IQ platform provides real-time information and historical data to support troubleshooting.

The Martin Control & Equipment Company team began to receive Thermal IQ push notifications about the downward trend of the failing scanner as it strayed outside normal limits. They used the Thermal IQ mobile app to look at other thermal processes information in real time such as temperature, burner status, burner run state, fan status and burner demand without being present at their facility.

Because the Martin Control team knew exactly what the problem was by comparing data in the Thermal IQ historian and remotely logging into SLATE, their service technician brought the correct tools and parts for a first-time fix, including a more robust Honeywell Industrial Flame Monitoring (IFM) scanner. This was a critical advantage given the two-hour transit time and the amount of revenue potentially lost if the problem was not rectified right away.

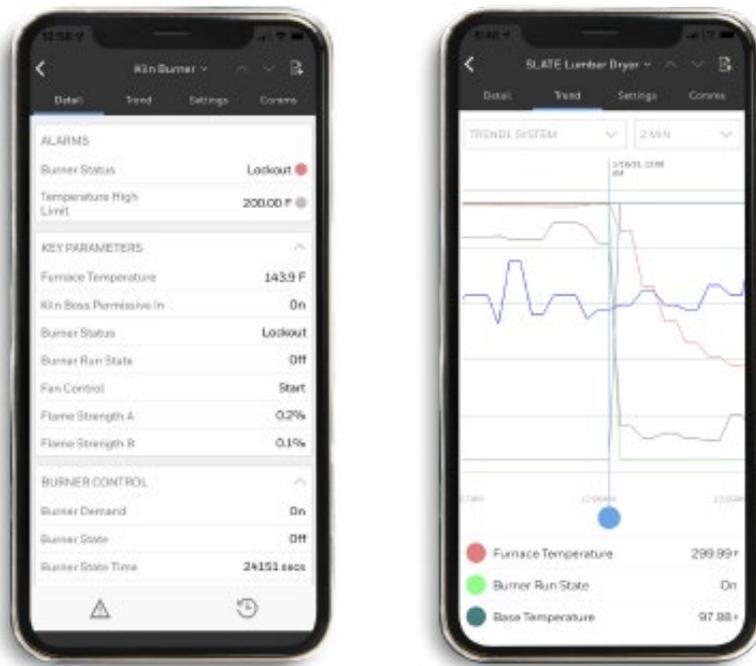
*Real-time monitoring and alerts drove visibility to the remote Martin Control team.*

*The teams were able to compare operating parameters to better understand what was occurring prior to and after the lockout for enhanced troubleshooting.*
